**INSPECTION OF VITREFLON 700 COATED FAÇADE
NAB BUILDING, 800 BOURKE ST, MELBOURNE**

Agreement :
Report No: XC3233
Issue date: 1 November 2013

CMSE REPORT XC3233

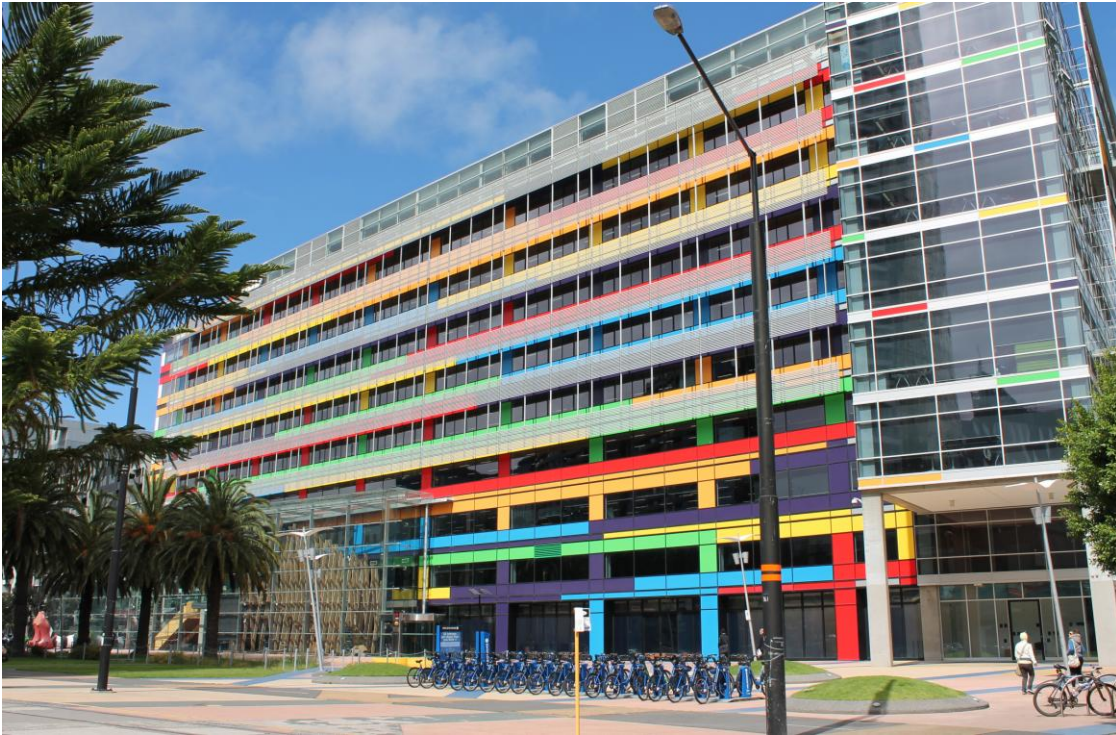
Figure 1: North Face of the NAB Building

The National Australia Bank building is located at 800 Burke Street, Dockland. The building is the Headquarters of NAB and construction commenced in 2002 and completed in 2004. The facade of the building consists of FRC panels painted with one coat of Vitrecure 10 UV cured undercoat followed by one coat of Vitreflon 700 two pack based finish. The paint finish was applied in February 2003. The building is quite striking because of the bold colours used on the facade (Fig1)

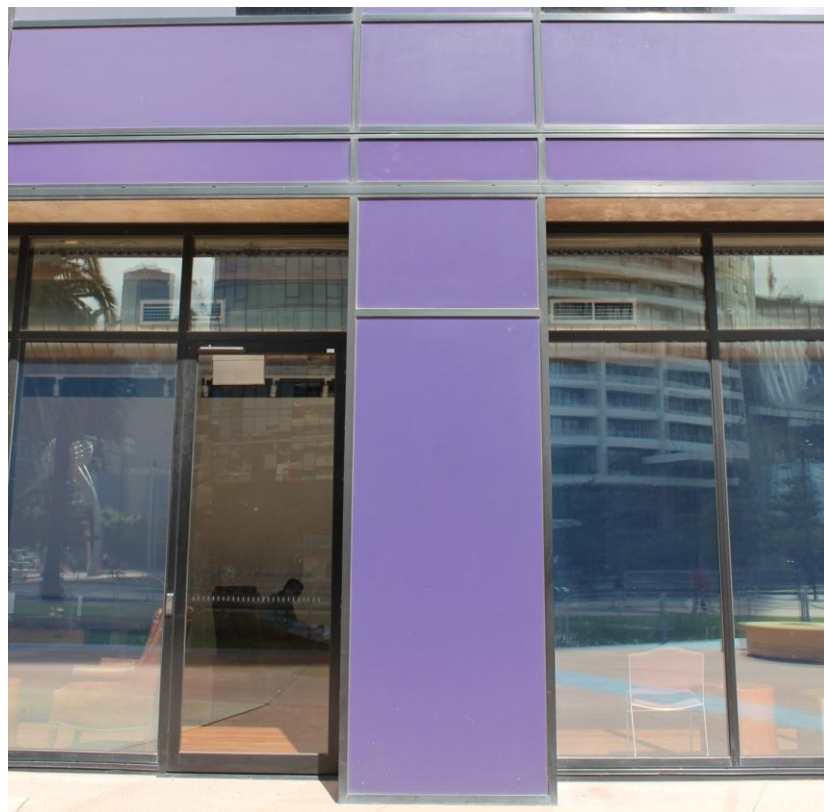
Figure 2: The Ground Floor Blue Violet Panel

The inspection was undertaken on the 29 October 2013 in company with Mr Peter Gillies. Only the ground floor panels on the north facing side were fully accessed during the inspection. These consisted of the purple, blue and red panels (Figs 2, 3 & 4). Only a visual assessment was made of the panels above ground level was made by the author.

For the colour change, the facade coatings were compared with the colour swatches provided by Mr Peter Gillies using ISO 105 A02: Grey Scales. The results are detailed in Table 1 and show that there has been no integrity failure, change in gloss and only a very slight change in colour (lightening).

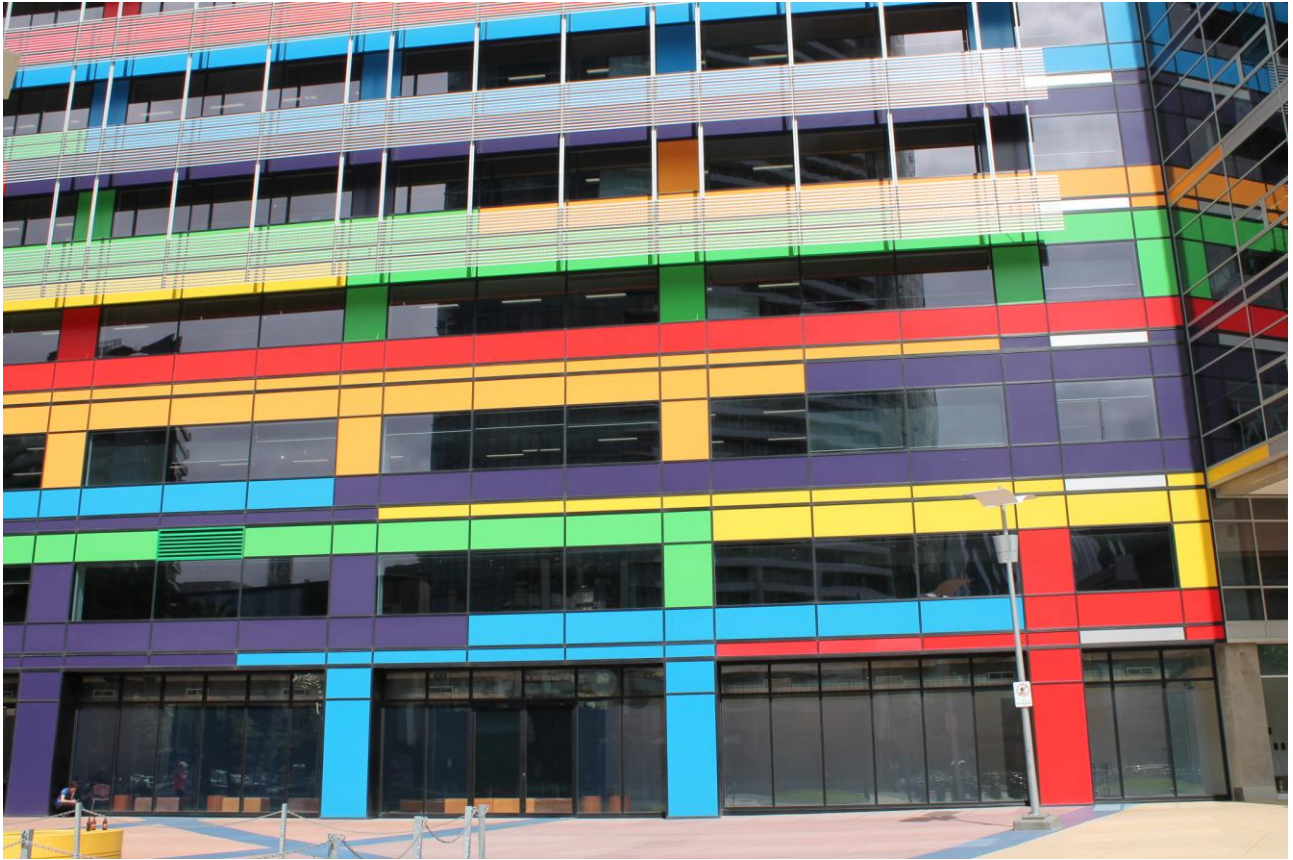
- There was no discernable visible integrity failure in any of the areas or change in gloss.
- The panels had not been subject to a regular cleaning regime and hence there was some dirt build up.
- In addition to the Blue Violet, Regatta Bay and Bright Red, the Green (Jack O Lantern) and the Light Yellow (Sunny Side Up) was also viewed. In the ground floor panels a very slight lightening of the colour was observed. However, the dirt build up on the second floor acted to darken the colour and in essence the colours were a match with the original colour swatch.

Figure 5: First & Second Story showing the Yellow and Green Colours
